EMERGENCY CULVERT REPAIR ON VERMONT ROUTE 116 WITH KUSTOMFLO HDPE PIPE

An effective solution to reopen a washed-out roadway

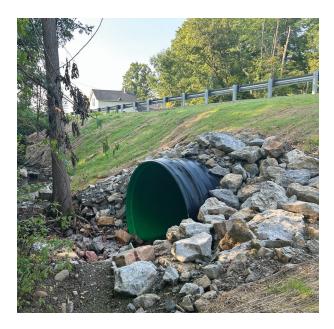
The installed product consisted of 93.5 linear feet of 94.5-inch KUSTOMFLO pipe. The pipe was intentionally oversized to allow for partial burial of the invert, enabling the installation of riprap to support aquatic life passage. Soleno's ability to meet the tight timeline, combined with its emergency readiness and in-stock availability, ensured that the road could be reopened within a week.

Soleno responded promptly to the emergency request, using its stock of KUSTOMFLO pipes to address the situation effectively. By mid-week, 93.5 linear feet of 94.5-inch KUSTOMFLO pipe was shipped, and the contractor, Kubricky Construction Corp, installed the pipe by Friday. The road was reopened shortly thereafter, significantly minimizing disruption to local transportation.
